INCIDENT SUMMARY

February 2026

Safety Performance in February 2026

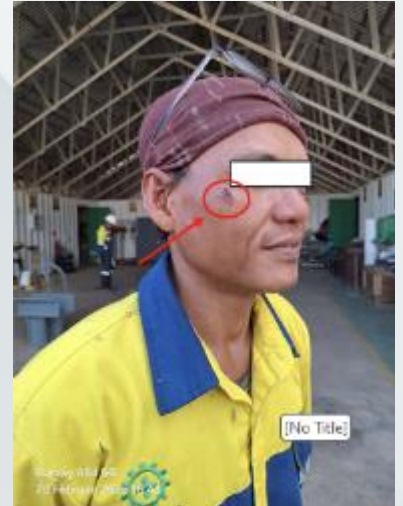
When the IP finished cutting the 200 mm UNP inside the workshop and was about to continue cutting the 150 mm H-Beam outside, the oxy-acetylene hose became stuck. The IP pulled the hose forcefully and turned his body without paying attention to the surrounding area. Unintentionally, the IP moved too close to the oxy-acetylene trolley, causing the right cheek of the IP to hit the trolley handle, whose plastic protective cover was already damaged.

- Always stop for a moment to observe the surroundings before moving or shifting equipment.
- Conduct a P2H before starting work to identify damaged, sharp, or unsafe equipment so that it can be repaired or replaced immediately.
- The importance of good housekeeping to prevent workers from the risk of tripping, snagging, and bumping into objects, especially by placing hoses/cables safely so they do not obstruct movement.
- Avoid using excessive force to pull hoses or tools. If they become stuck, stop the work and identify the cause.

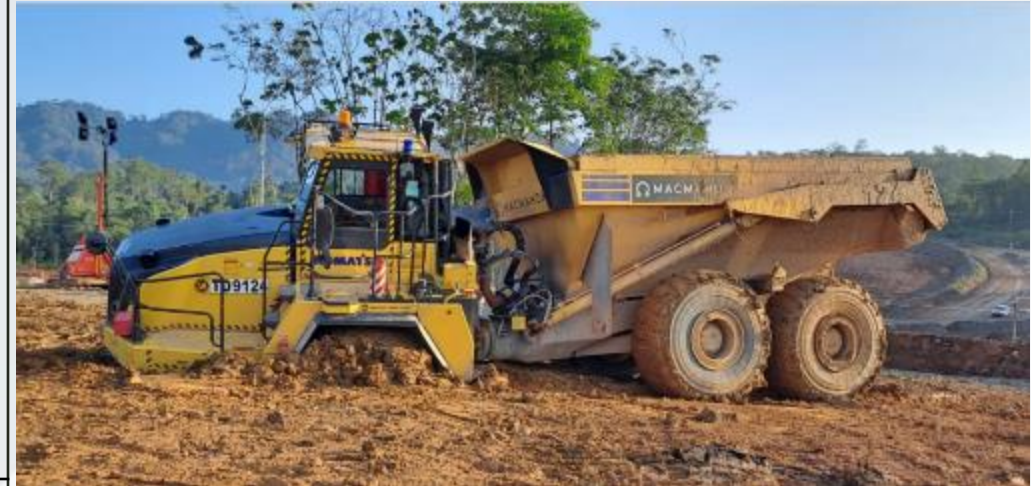
At the beginning of the shift, Operator ADT TD9124 received instructions to load at the leachate pond and dump at stockpile SWD 1B. While moving towards the loading point and the unit moved 20 meters forward, the POS#1 tire could not move, causing it to sink. Then the operator reported the incident to the supervisor. There were no injuries or damages in the incident.

- Identify hazards around the work area to ensure there are no hazards and risks when the unit is about to move.
- Check the work area and communicate with the spotter or area supervisor when you decide to stop or park in that area.
- Complete the emergency equipment (towing sling) and also the Spotter for operational areas that are prone to subsidence.

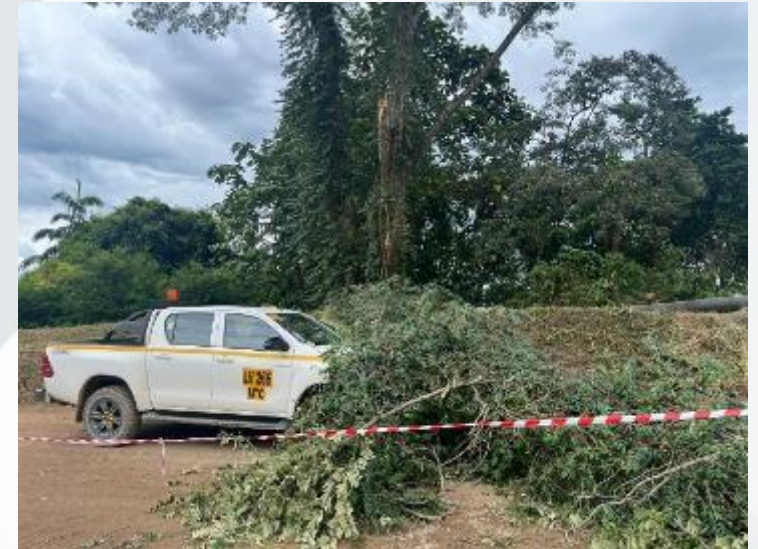
After completing the job inspection at Sedimen Dam 2, LV 266 moved back towards the Maintenance office. When passing through the intersection of Jalan 3 access, a broken branch of a sengon tree fell and hit the front of LV 266, causing the engine cap to dent. No fatalities or injuries to the operator were reported

- Identification and Mitigation of Natural Hazards – Vehicle movement areas must be inspected for potential environmental hazards, such as trees or branches prone to breaking.
- Vehicle Speed and Caution – When passing through areas with the risk of falling trees or objects, vehicles must be operated cautiously, and the speed must be adjusted accordingly.
- Area Maintenance and Routine Monitoring – Regularly carry out tree trimming and inspections along vehicle access roads to prevent potential damage or accidents.

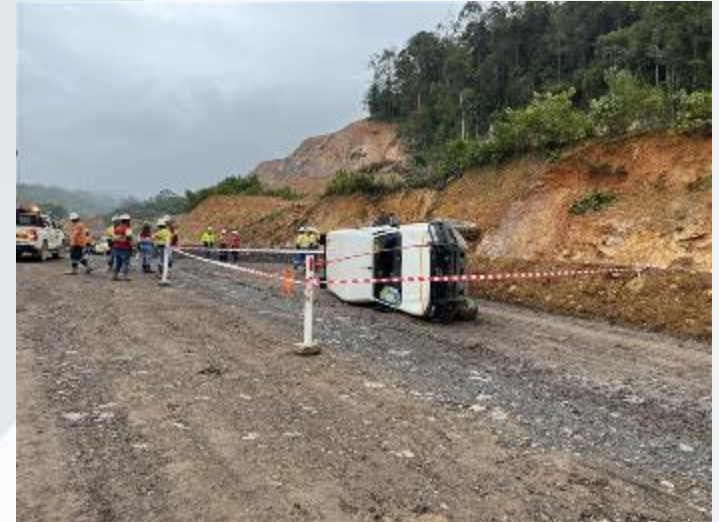
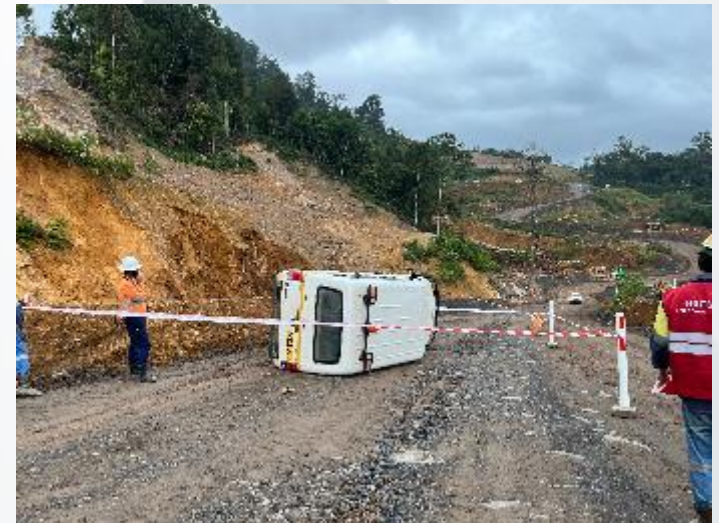
While LV MMS 219, operated by the MPDSE Supervisor, was travelling from the Pondok 5A parking area to Pond 5B, the vehicle passed through the TMF West downhill access road. While travelling downhill, the vehicle's left tyre climbed onto the safety berm on the left side of the road. This condition caused the vehicle to lose balance and eventually tip over to the right side.

- Comply with the Golden Rules No1: "PROHIBITED to work in a state of fatigue (Tired/Sleepy) or under the influence of alcohol or drugs..
- Manage your break time by sleeping 6-8 hours and report to your supervisor if you experience fatigue.
- Micro Sleep can be fatal when you are driving a vehicle.

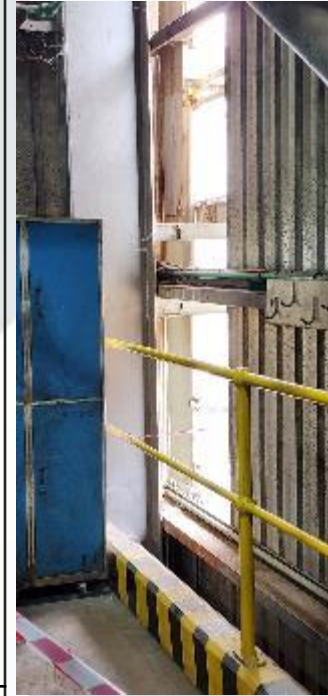
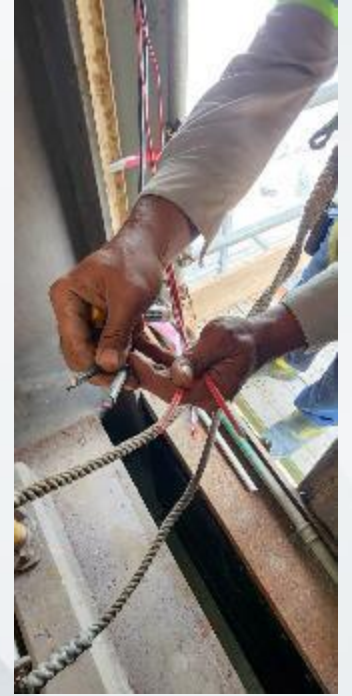
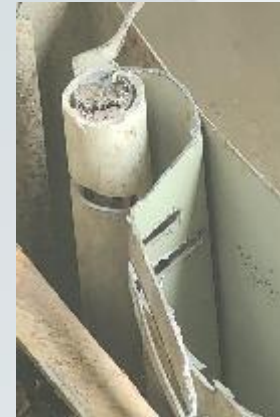
A worker from CV HDL, while removing cladding for the demolition and installation of purlins, accidentally cut a conduit pipe containing inactive CCTV cables. The incident occurred while cutting the cladding at the corner of the building using scaffolding. There was a second layer of cladding covered by flashing, so the flashing had to be removed first. After the cutting, the vertical white conduit pipe was also cut. The Electric team confirmed that the CCTV cable came from an old redundant path that was no longer in use and without electrical current.

- Conducting hazard identification before work is carried out, especially for Hidden Installations in cladding areas that structurally allow for installations not visible from the outside.
- Ensure the as-built drawing is checked (if required) before starting the work.
- Implement the established procedures for the task.
- Maintain active communication among workers and between all parties involved in the work.

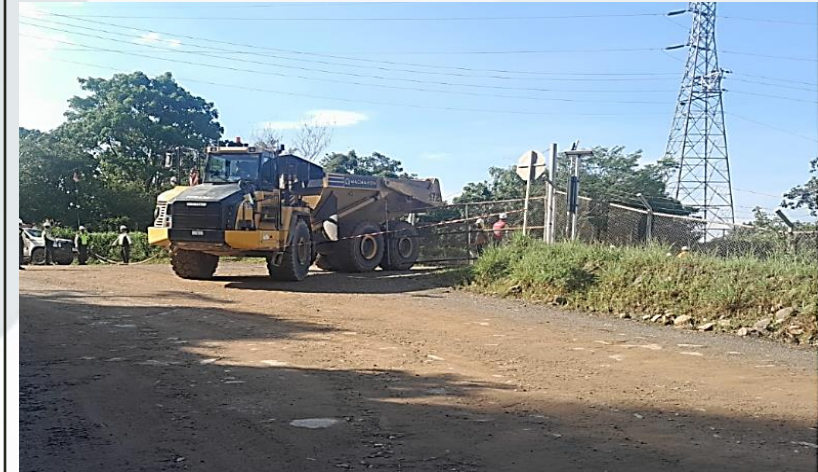
At the beginning of the shift, the operator received instructions to load material in the Batching Plant area. The operator of ADT TD9172 was directed to turn through the Basalt Quarry storage area. While exiting through the upper gate, the operator passed through the open right side, while the left gate was still closed. During this process, the left vessel side, as well as tires POS#3 and POS#5, came into contact with the left gate, resulting in damage to the gate.

- Inspection/Identification of Gate and Exit Route: Operators must ensure that both sides of the exit route are safe, unobstructed, and sufficiently wide for the ADT before passing through.
- Two-Way Communication with Supervisor: Any changes in field conditions—such as the absence of a spotter or a closed gate—must be immediately communicated to the supervisor or security personnel in the area before continuing the movement.
- Implementation of the “Stop-Call-Wait” Rule: If unsafe conditions are encountered (such as a closed gate, narrow route, or lack of guidance), the operator must stop, report the situation, and wait for further instructions.

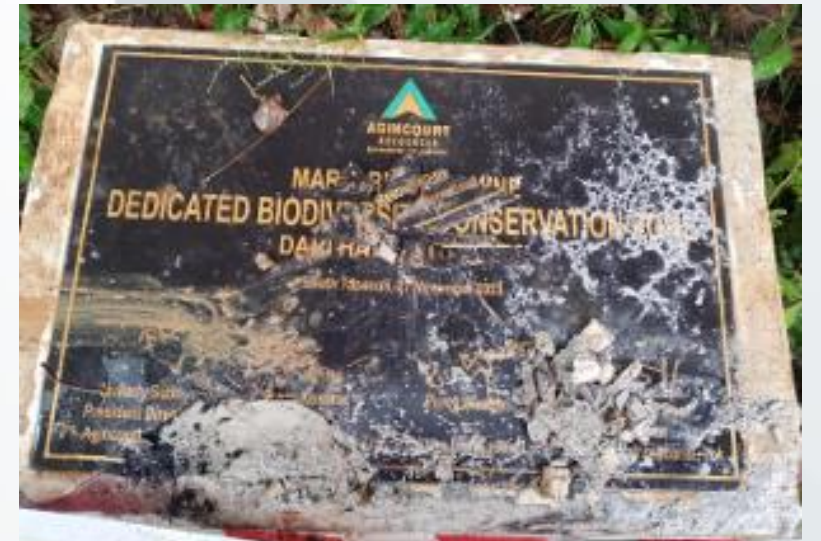
At approximately 11:00 PM, the main work was temporarily stopped due to rain. To prevent water accumulation, the Supervisor instructed the opening of a blocked drainage channel at the Sabar Dump intersection. At around 11:10–11:20 PM, the excavator carried out water release by swinging approximately 15–20° under rainy conditions with limited visibility, and the unit position also restricted the operator's view toward the stake area. Based on the time and location, the damage is suspected to have occurred during the drainage opening process, although no direct impact was identified.

- **Checklist and Risk Identification** – All fixed objects within the work area must be recorded in the checklist and communicated to the team to ensure they are not overlooked.
- **Object Marking and Protection** – Stakes or other risk-prone objects need to be clearly marked or provided with physical protection, especially when visibility is limited.
- **Supervision and Condition Adjustment** – Work activities must be adjusted according to weather and site conditions; supervision must ensure that critical areas are clearly visible or that additional spotters are assigned.

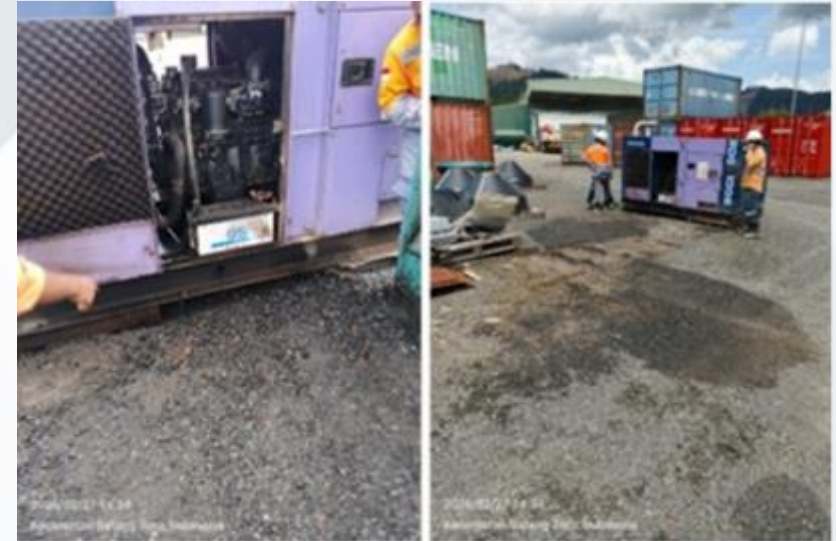
At 11:00 AM, we found a rental generator owned by MPDS located in the SCM area with a diesel spill coming from the unit. The generator had been in the SCM area since January, waiting for transportation to be returned to the supplier.

- The importance of draining fuel and oil if the generator is stored for a long period of time to prevent potential undetected leaks.
- If the generator is not drained, periodic inspections of the generator must be carried out.
- Installation of secondary containment even when the equipment is in a non-operational condition.
- Regular inspection of the work area and implementation of housekeeping in the storage area (yard).
