# HSE Alert

## Pembelajaran dari Insiden Fatality Karena Terbawa Arus di Tambang Lain

## Lessons Learned from a Fatality Incident Due to Being Swept Away at Another Mine

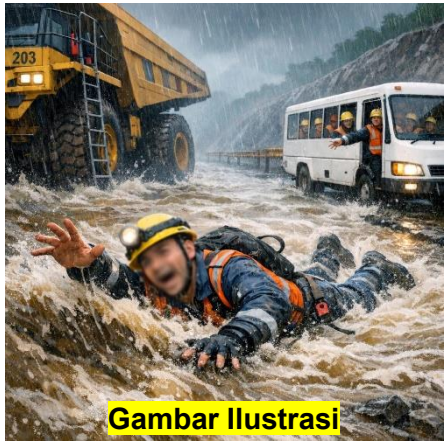
<b>DESKRIPSI</b>	<p>Pada tanggal 4 Maret 2026 lalu, telah terjadi kecelakaan tambang di tempat lain berakibat fatality yang disebabkan karena terbawa arus air hujan.</p> <p>Berdasarkan informasi yang didapat, kejadian bermula saat hujan deras mengakibatkan terjadinya limpasan air hujan di jalan tambang yang cukup deras dan terdapat alat berat (HD) yang masih berada di jalan tersebut dengan posisi berhenti. Pada saat bersamaan unit manhaul yang akan menjemput operator HD (IP) berhenti di samping unit HD (jarak +/- 2 meter). Lalu IP turun dari unit untuk berpindah ke Man Haul namun dikarenakan arus air yang deras, IP terbawa arus air hujan sehingga mengakibatkan fatality.</p>

<p style="color: yellow; background-color: black; padding: 2px; display: inline-block;"><b>Gambar Ilustrasi</b></p>
<b>TINGKAT RISIKO</b>	EKSTRIM	
<b>PELAJARAN PENTING</b>	<p>Saat ini, dalam lingkungan kerja PT. Agincourt Resources, sudah dilakukan sejumlah upaya untuk mencegah kecelakaan serupa terjadi, antara lain:</p> <ol style="list-style-type: none"> <li>1. Pemantauan curah hujan dan pengendalian debit air.</li> <li>2. Notifikasi Hujan lebat akan di informasikan oleh CCC PTAR melalui email dan juga melalui radio (Channel 9) oleh operator radio room.</li> <li>3. Pemasangan stik indicator level air pada setiap titik aliran air yang melintang pada akses jalan.</li> </ol> <p>Namun dari kejadian tersebut, yang dapat kita lakukan jika terjadi hal serupa di area kerja kita adalah:</p> <ol style="list-style-type: none"> <li>1. <b>Larangan turun kendaraan:</b> Arus air hujan yang terlihat "dangkal" sekalipun (setinggi mata kaki) memiliki kekuatan untuk menyapu orang dewasa. Jika terperangkap banjir di jalan, tetap di dalam kabin dan hubungi pengawas atau CCC PTAR.</li> <li>2. <b>Prosedur hujan lebat:</b> pemantauan curah hujan dan notifikasi dari CCC/ Radio (Ch 9) harus segera ditindaklanjuti dengan menghentikan aktivitas dan bergerak menuju Muster Point yang telah ditentukan, bukan menunggu hingga air meluap.</li> <li>3. <b>Posisi kendaraan saat darurat:</b> Saat kondisi darurat, jangan pernah memarkir kendaraan berdampingan (paralel) di jalan yang tergenang aliran air. Beri jarak aman dan posisikan kendaraan di luar jalur aliran air.</li> <li>4. <b>Gunakan alat bantu:</b> Stik indikator level air yang telah dipasang harus dijadikan acuan. Jika air telah mencapai level warning, jalan tidak boleh dilalui oleh kendaraan ringan maupun pejalan kaki.</li> </ol>

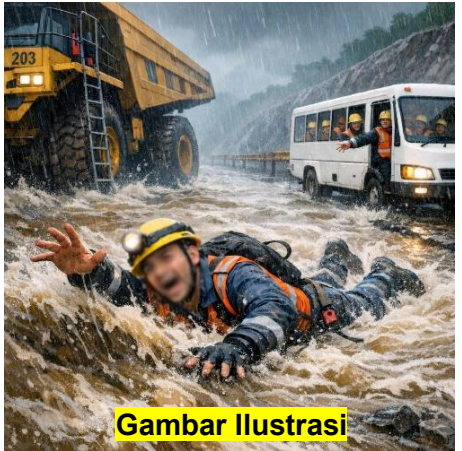
<b>DESCRIPTION</b>	<p>On March 4th, a fatal mining accident occurred at other mine, due to being swept away by rainwater runoff.</p> <p>Based on the information obtained, the incident began when heavy rain caused significant rainwater runoff on a mining haul road, where a heavy-duty vehicle (HD) was stopped on the road. At the same time, a manhaul unit that was going to pick up the HD operator (IP) stopped next to the HD unit (at a distance of +/- 2 meters). The IP then got out of the unit to transfer to the Man Haul, but due to the strong current of water, the IP was swept away by the rainwater runoff, resulting in a fatality.</p>

<p style="background-color: yellow; display: inline-block; padding: 2px;">Gambar Ilustrasi</p>
<b>RISK RATING</b>	HIGH	
<b>KEY LEARNING</b>	<p>Currently, within the work of PT. Agincourt Resources, a number of efforts have been implemented to prevent similar accidents from occurring, including:</p> <ol style="list-style-type: none"> <li>1. Monitoring rainfall and controlling water discharge.</li> <li>2. Heavy rainfall notifications will be communicated by the CCC PTAR via email and via radio (Channel 9) by the radio room operator.</li> <li>3. Installation of water level indicator sticks at every point where water flows crossing the road access.</li> </ol> <p>However, from this incident, here is what we can do if a similar situation occurs in our workplace:</p> <ol style="list-style-type: none"> <li>1. <b>Do not exit the vehicle:</b> Even if the flowing rainwater appears "shallow" (ankle-deep), it has enough force to sweep away an adult. If trapped by flooding on the road, remain inside the cabin and contact your supervisor / the CCC.</li> <li>2. <b>Heavy rain procedure:</b> Monitoring rainfall and notifications from the CCC / Radio (Ch 9) must be followed up immediately by stopping activities and moving to the designated Muster Point, rather than waiting for the water to overflow.</li> <li>3. <b>Emergency vehicle positioning:</b> During an emergency, never park vehicles side-by-side (parallel) on a road that is submerged in flowing water. Maintain a safe distance and position the vehicle away from the flow path of the water.</li> <li>4. <b>Use assistive tools:</b> The installed water level indicator sticks must be used as a reference. If the water has reached the warning level, the road must not be used by light vehicles or pedestrians.</li> </ol>
