INCIDENT SUMMARY

March 2026

Safety Performance in Marc 2026

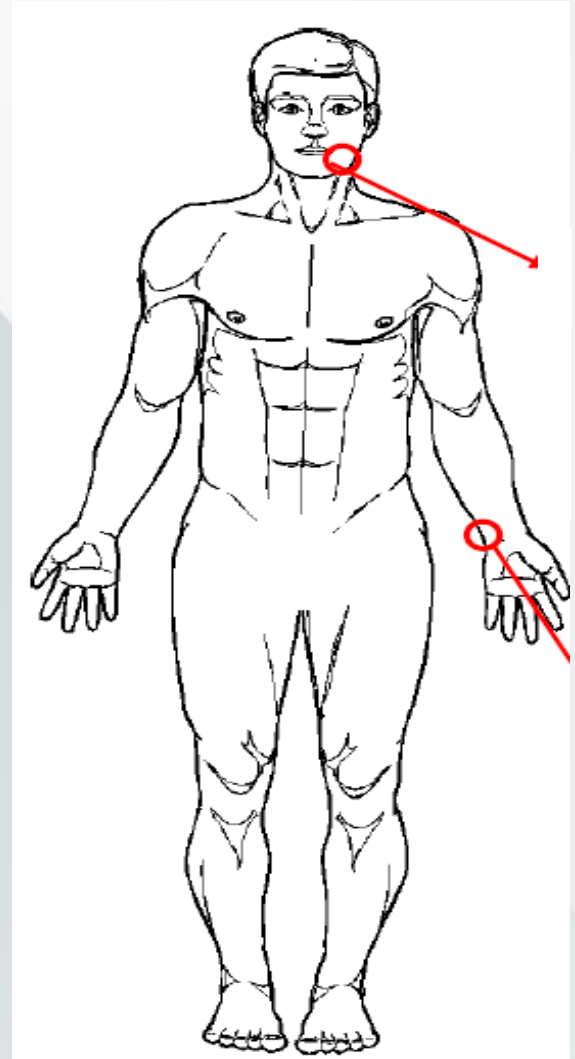
When about to inspect the water channel leading to the dissipater in front of the RWT access area, the IP was standing on the berm embankment. An insect stung the left cheek, and the IP's left hand reflexively waved the insect away, causing the left wrist to also be stung by the same insect.

- Always conduct hazard identification (biological hazards, hidden hazards, etc.) in the work area.
- Avoid using strong perfumes or fragrances when working near bushes or forests to prevent attracting insects.
- Use appropriate PPE, such as a "bee net," when insect or bee hazards are identified.

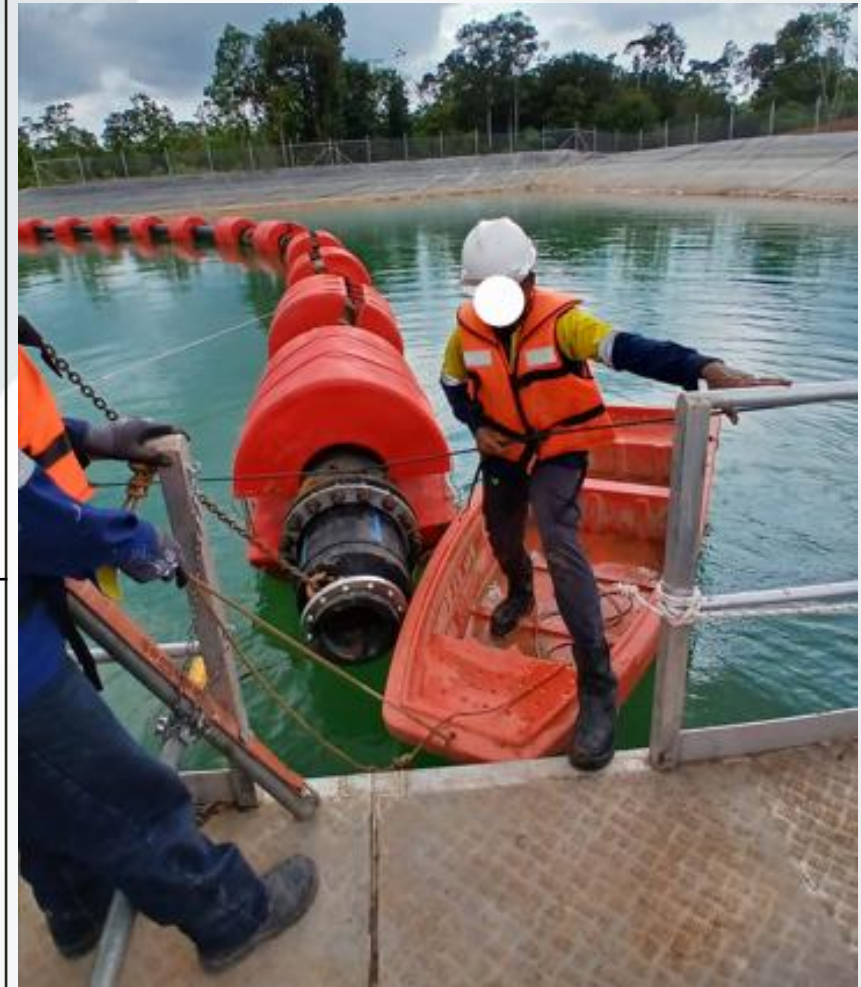
While continuing the pontoon installation work at SD6B, the worker returned to the pontoon by boat. As the worker stepped onto the pontoon platform, the boat drifted away, causing the worker to fall into the water. The worker was wearing a life jacket, and no physical injuries (impact) were sustained. The water pH at the time of the incident was 6.2.

- Ensure the boat is stable before stepping to transfer from the boat to the pontoon.
- Review and/or implement procedures that include better communication between the boat operator and the worker, the use of handholds, and ensuring the boat is properly moored.
- Always wear appropriate PPE, such as a life jacket, when working near and/or over water.

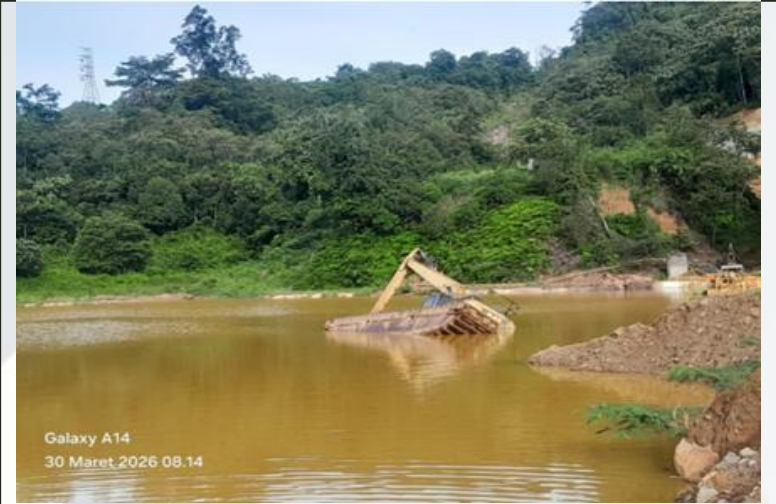
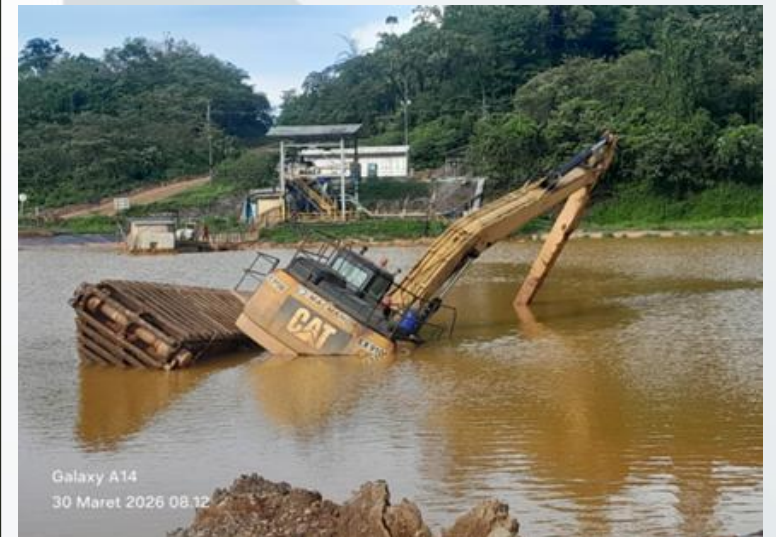
The amphibious excavator operator (EX9106) received instructions from the supervisor to carry out sediment loading work in the SD1 pond. The unit moved slowly from the SD1 jetty into the pond. Approximately 20 meters from the edge of the pond, the front right side of the pontoon suddenly tilted and gradually began to sink.

- Ensure that the results of the risk assessment are communicated to all involved workers and that all recommendations have been implemented.
- Work instructions must be delivered clearly, specifically, and confirmed (closed-loop communication) to avoid misinterpretation in the field.
- All supervisors must have a shared understanding of the work plan. Poor coordination can lead to inconsistent instructions and increase the risk of accidents.
- If identified hazards and risks have not yet been addressed, stop work and communicate this to the supervisor.

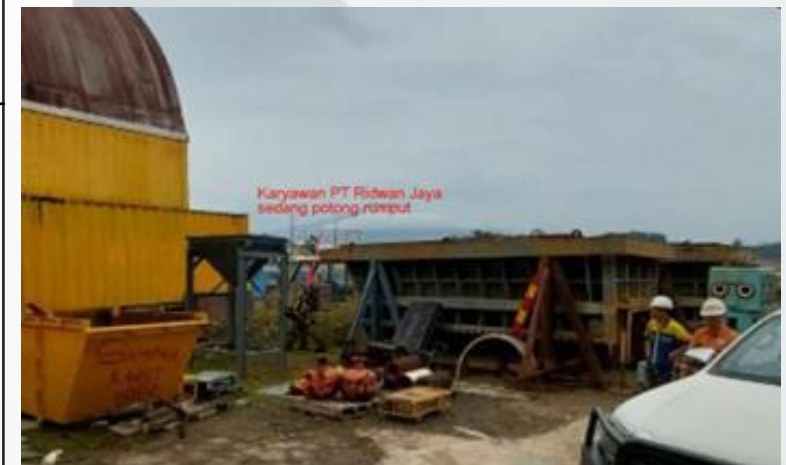
At 03:00 PM, an LV driver from PT Minindo Jaya parked the vehicle in front of the Rubber Highland Workshop (Minindo). Before parking, there was a grass-cutting/clearing activity in the former insert chute area not far from the parking location.

At 05:00 PM, when the Minindo employee was about to use the vehicle again, they noticed that the front right window of the LV was already cracked/broken.

- Identify hazards and risks when deciding to park your vehicle in a high-risk area.
- Apply appropriate controls to your vehicle if potential hazards are identified around the parking area.
- Assess the work area for vehicle parking placement and ensure it is equipped with adequate controls (Parking Signs and Stop Bar).

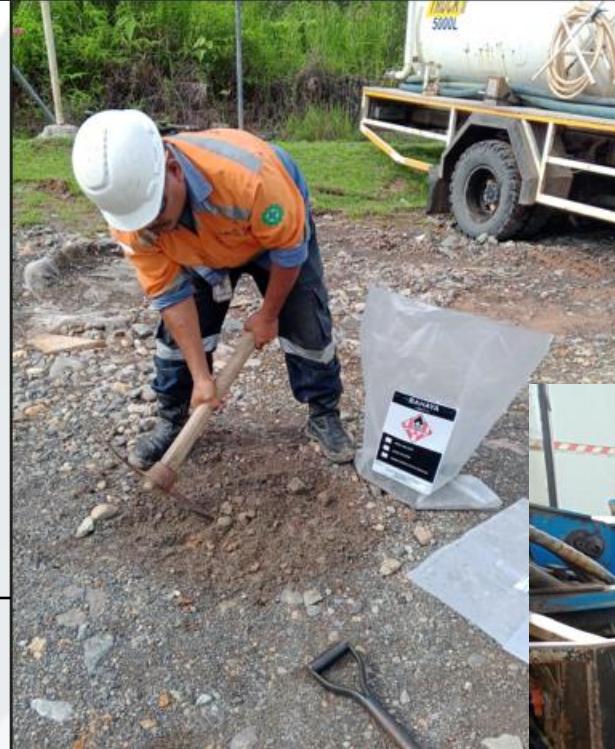
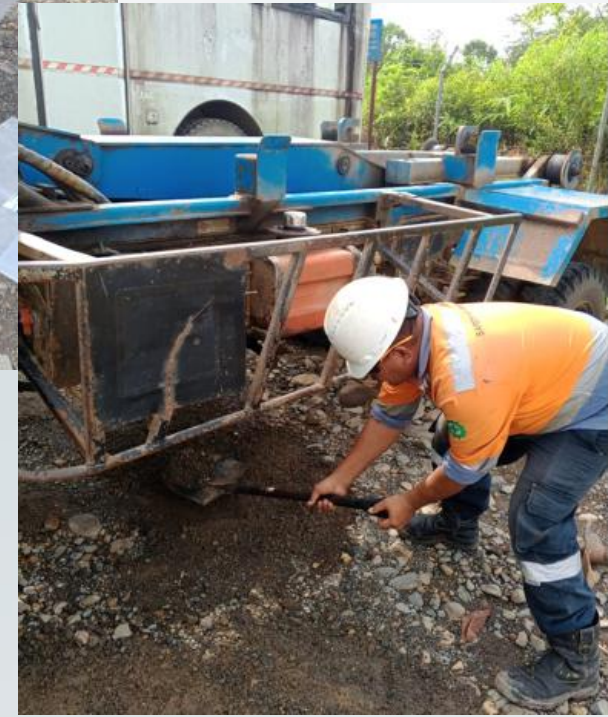
On March 6, 2026, at 09:00 AM WIB, a hydrocarbon spill was found in the Manhaul Pelangi parking area beneath unit GT-02. The incident was reported to the Facilities team for immediate cleanup of the contaminated soil.

- Perform a routine pre-use check before operating the equipment. Check for any seepage or drips under the unit.
- Even the smallest leak must be reported immediately to the mechanics team for repair. Taking shortcuts, such as “leaving it for later,” is the beginning of a disaster.
