# INCIDENT SUMMARY

July 2026

**AGINCOURT**  
RESOURCES  
MEMBER OF ASTRA

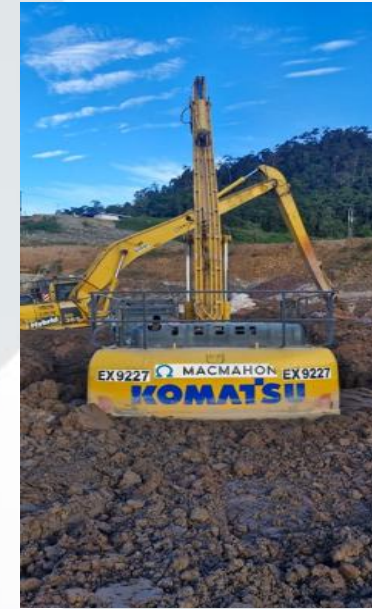
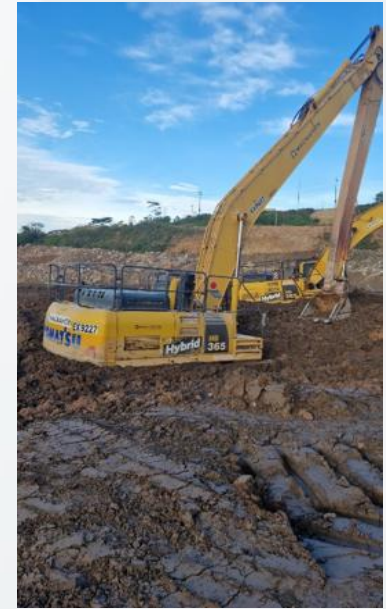
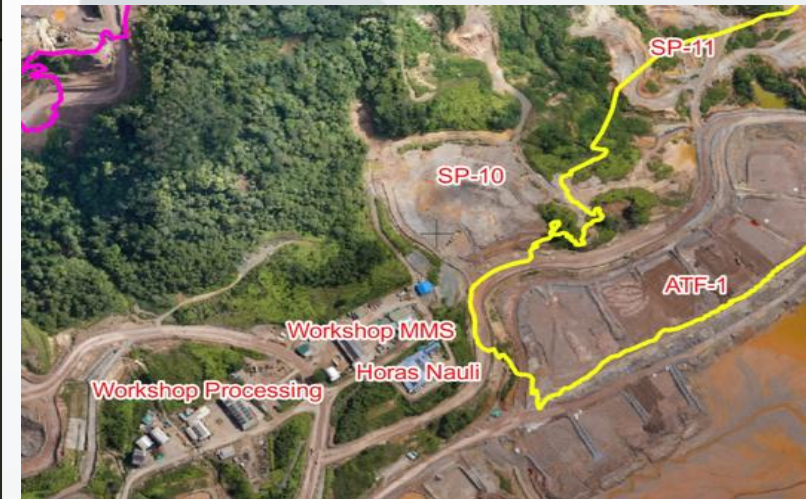
**Location: ATF-01**

The Long Arm Excavator Unit 9227 was traveling from Block 3 to the parking area. However, the access route was not passable, and the operator decided to use an alternative route through Block 2 and Block 1. While traveling along the alternative route, the unit became bogged down. Subsequently, the Supervisor instructed Excavator Unit 9197 to perform cleaning activities on the right side of Unit 9227. However, EX 9197 also became bogged down in the same area.

- Comply with all applicable work procedures/SOPs and avoid taking shortcuts or deviating from established procedures under any circumstances.
- Conduct a risk assessment before and during travelling activities, and avoid making immediate decisions without proper risk evaluation.
- Ensure effective communication between operators and supervisors, and do not deploy other equipment into areas that have not been confirmed as safe.
- Enhance geotechnical inspections in work areas with potential soft ground conditions and apply the **“Stop Work Authority”** principle.

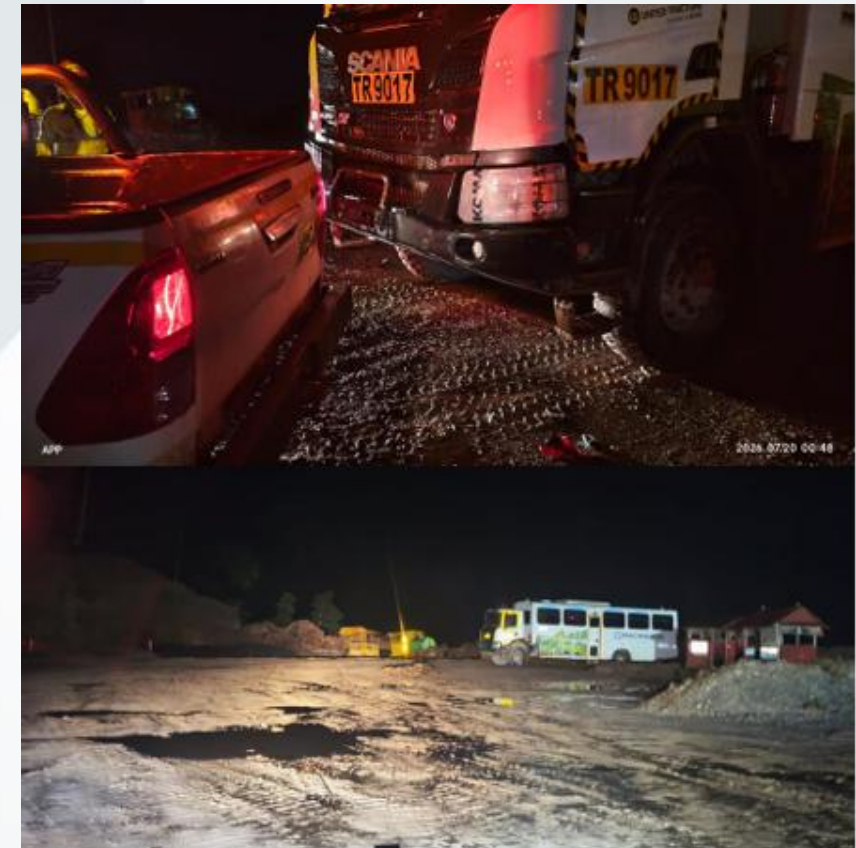
**Location:** Pit Barani 290 RL

On 19 July 2026 at approximately 23:30 WIB, a contact incident occurred between LV MMS 059 and Manhaul TR9017 at Pit Barani. The incident occurred when the LV driver was reversing the vehicle after dropping off an operator at the manhaul for hot seat preparation. The right rear bumper of LV MMS 059 made contact with the left front bumper of Manhaul TR9017, which was parked with the engine switched off. At the time of the incident, the weather conditions were foggy and rainy, resulting in limited visibility. The incident resulted in damage to the right rear bumper of LV MMS 059, which was dented, and the right rear lamp glass was broken.

- Ensure the area is safe before performing any maneuver, particularly when reversing in areas with limited maneuvering space.
- Do not perform maneuvers when visibility is limited due to fog, rain, poor lighting, or other environmental conditions.
- Stop or postpone the maneuver until conditions are safe and suitable.
- Use a spotter/guide when the driver's visibility is limited or when there is a potential risk of contact with other equipment or vehicles..

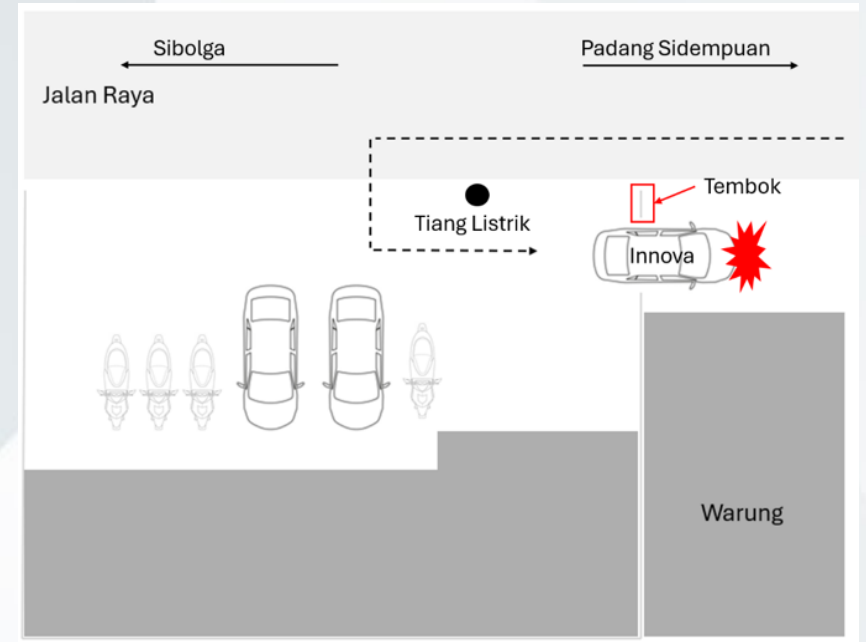
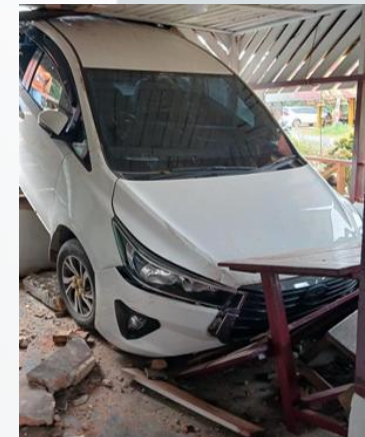
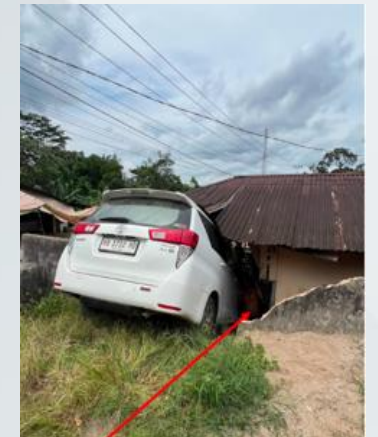
**Location:** Sibabangun Highway

While attempting to park an Innova vehicle at a restaurant, the designated parking area was already occupied by other vehicles and motorcycles. The driver then steered the vehicle to the left toward an available parking area. The driver pressed the clutch pedal and assumed that the brake pedal had also been pressed. The driver then released their foot from both the clutch and brake pedals, causing the vehicle to continue moving. The vehicle subsequently struck a wall and then fell into a food stall area located at a lower elevation than the parking area.

- Comply with GOLDEN RULES No. 2: Do not operate vehicles or heavy equipment without having an appropriate and valid SIMPER (Site Driving Permit).
- Ensure that only drivers with a valid SIMPER, appropriate for the type of vehicle and their authorized competency, are permitted to operate company vehicles, both inside and outside the site.
- Ensure that every vehicle leaving the site has a valid Exit Permit that has been approved by the General Manager Operation or authorized personnel, or the relevant Department Manager or authorized personnel, in accordance with applicable requirements.
- Conduct SIMPER and Exit Permit verification before any vehicle is operated or leaves the site to ensure that all requirements and authorizations have been fulfilled.

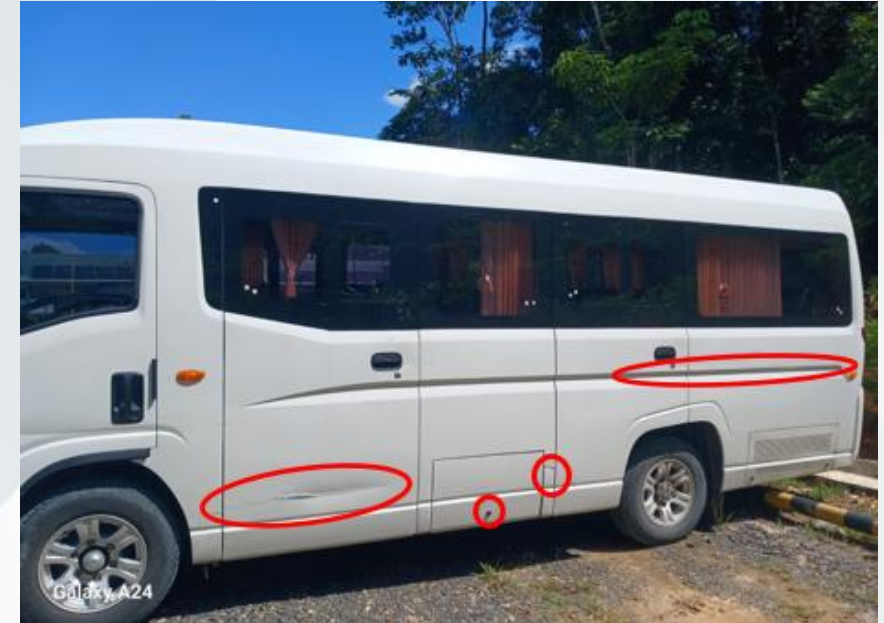
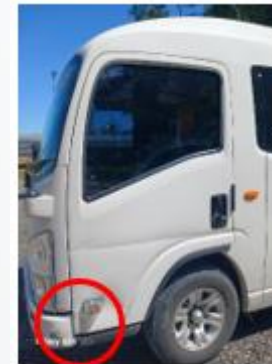
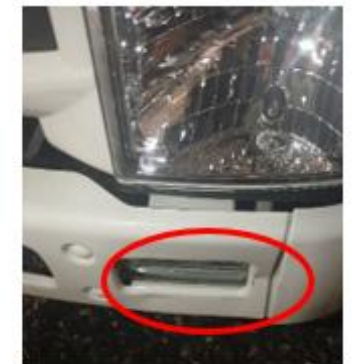
**Location:** Pinangsori – Site Highway

While transporting employees from Martabe Site to Pinangsori Airport, SB15 made contact with a motorized pedicap (*becak*) at Sibabangun Traditional Market. On the return trip from Pinangsori Airport, SB15 made contact again with another motorized *becak* for the second time in front of Indomaret Pinangsori. Approximately 500 meters further along the route, SB15 made contact with a motorized pedicab for the third time.

- Immediately report any incident to the supervisor and evaluate the vehicle condition before continuing the trip.
- Ensure the driver's readiness to continue the trip and immediately report to the supervisor if the driver feels unfit or unable to operate the vehicle safely.
- Stop the trip if the vehicle condition or driver condition is unsafe, and continue only with a replacement vehicle or driver.

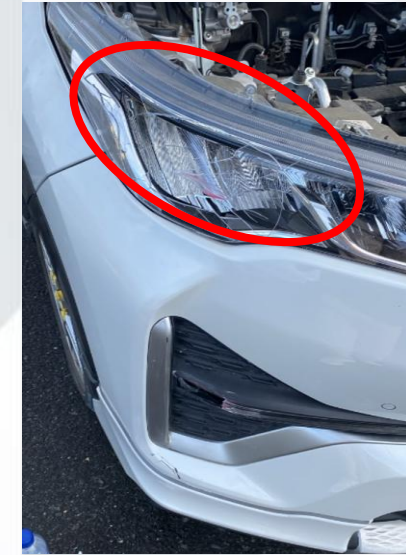
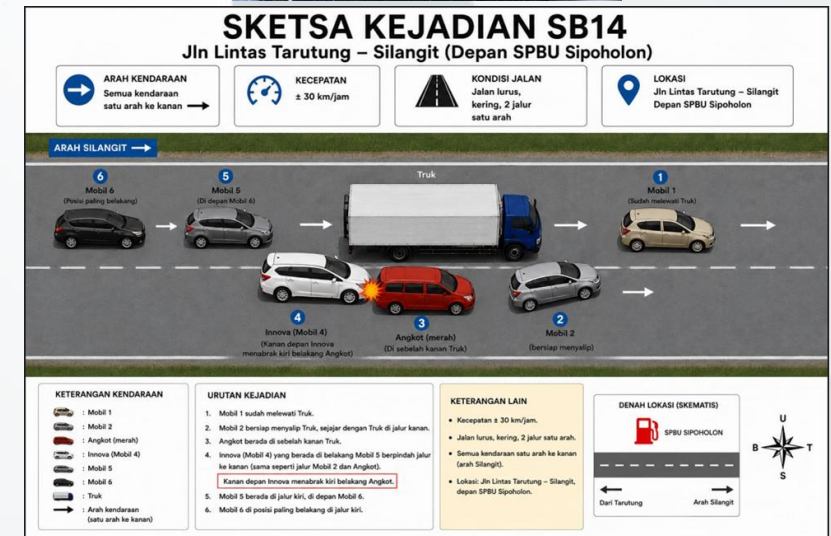
**Location:** Tarutung Highway

While travelling to Silangit Airport, SB14 was passing near Sipoholon Fuel Station (SPBU) where traffic conditions were relatively congested. The driver attempted to overtake a vehicle ahead. During the overtaking process, the public transportation vehicle in front suddenly stopped without providing any stop signal, and its brake lights were not functioning. The SB14 driver was unable to avoid the vehicle, causing the right front lamp of SB14 to make contact with the right side of the public transportation vehicle. As a result of the incident, the right front lamp cover of SB14 was damaged and broken.

- Maintain a safe following distance and anticipate the movements of vehicles ahead, especially in congested traffic conditions and when performing overtaking maneuvers.
- Ensure traffic conditions are safe before overtaking and do not rely solely on an apparent opportunity to pass.
- Increase awareness of vehicles that may stop or maneuver suddenly, including vehicles that do not provide proper signals.

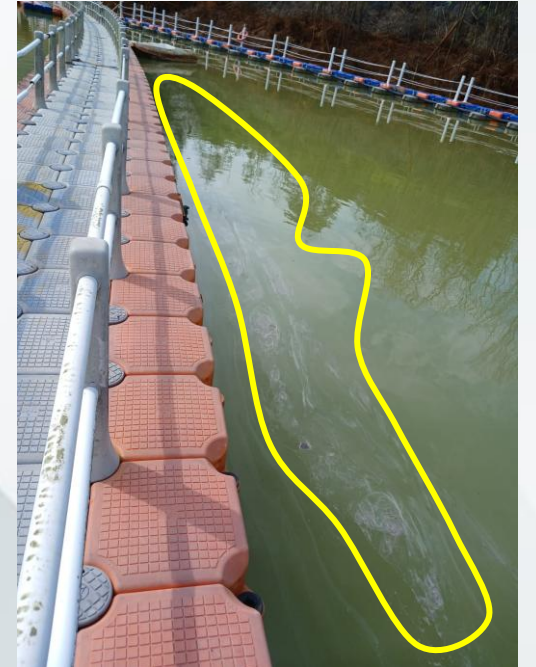
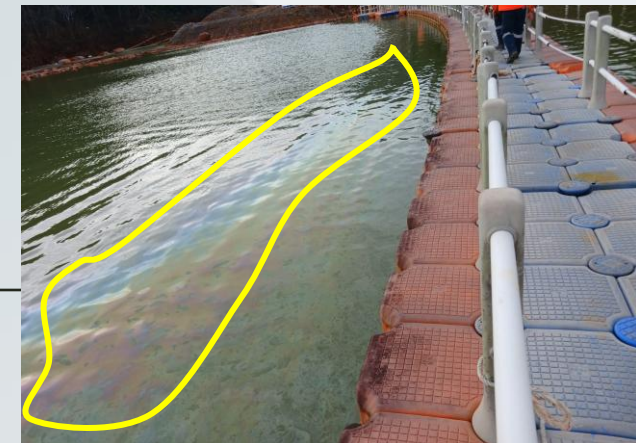
**Location:** Decant Spillway SP-09

The Day Crew Supervisor, while passing over the floating bridge of the decant pump after completing the silt curtain installation work, observed a thin layer of hydrocarbon floating on the surface of the decant water.

- Identify and control all potential sources of hydrocarbon spills in the work area, such as fuel, oil, grease, hydraulic oil, as well as connections/hoses that may be prone to leakage.
- Conduct thorough inspections of all areas under supervision and of any units/equipment before, during, and after operation, ensuring there are no leaks, hydrocarbon spills, or other conditions that may potentially cause pollution.
- Provide, place, and ensure the readiness of spill response equipment (spill kits/oil booms) in areas with potential spill or contamination risks. Ensure the equipment is easily accessible, in ready-to-use condition, and that personnel understand the proper procedures for its use.

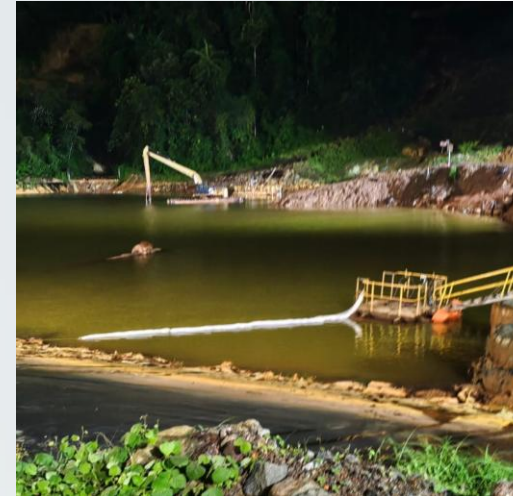
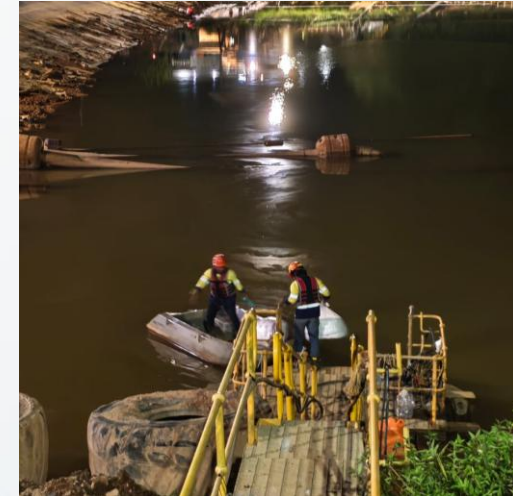
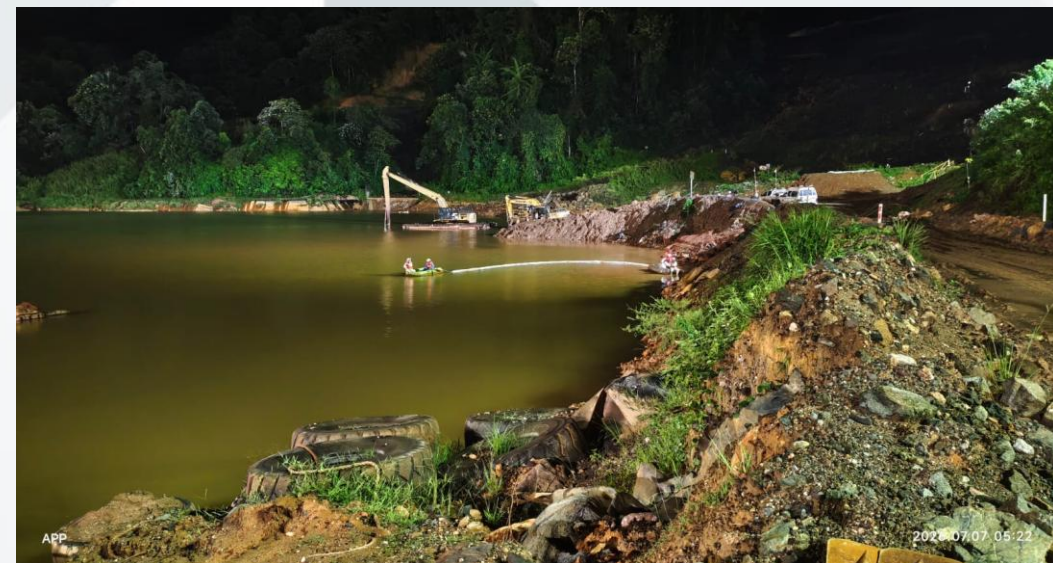
**Location: Sediment Dam 1**

While Excavator EX9106 was performing mud material transfer activities, the Supervisor instructed the operator to land the amphibious unit due to a scheduled service activity. During the travel process toward the landing area, the operator reported an oil leak. An inspection found that two travel motor mounting bolts on EX9106 had become detached, resulting in an oil leak with an estimated spill volume of approximately  $\pm 10$  liters into the SD1 pond.

- Conduct thorough inspections of all areas under supervision and of units/equipment before, during, and after operation.
- Any indication of oil leakage must be immediately followed up and properly addressed.
- Provide and ensure the readiness of spill response equipment (spill kits/oil booms) in work areas with potential pollution risks.
