# HSE Alert

## Excavator Amphibius Tidak Stabil saat beroperasi di Sediment Dam 1

<b>TANGGAL TERBIT</b>	<b>11 April 2026</b>

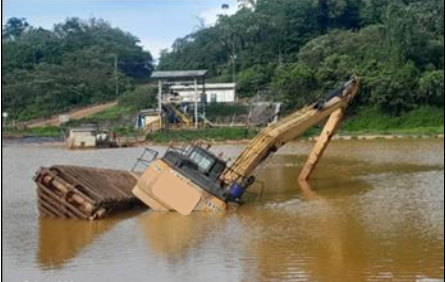
<b>DESCRIPTION</b>	<p>End of March, 2026, at approximately 08:02 AM WIB, the amphibious excavator received instructions from the supervisor to carry out mud material loading at the Sediment Dam 1 pond. The unit then moved slowly from the SD1 dock into the pond.</p> <p>At approximately 20 meters from the edge of the pond, the front right side of the pontoon suddenly tilted and gradually sank. This condition caused the unit to lean to the right. Upon seeing the situation, the supervisor instructed the operator via radio to immediately stop the unit's movement and get out from the cabin. The operator was evacuated by the ERT volunteers.</p>

<b>RISK RATING</b>	<b>HIGHT</b>	
<b>KEY LEARNING</b>	<p>Some key learnings from this accident may help prevent similar incidents in the future:</p> <ul style="list-style-type: none"> <li>• <b>Compliance with Risk Assessment is mandatory</b> Every recommendation in the risk assessment must be implemented without exception.</li> <li>• <b>Clarity of work instructions is crucial</b> Work instructions must be communicated clearly, specifically, and confirmed through closed-loop communication to avoid misinterpretation in the field.</li> <li>• <b>The importance of effective communication among supervisors</b> All supervisors must have a shared understanding of the work plan. Poor coordination can lead to inconsistent instructions and increase the risk of accidents.</li> <li>• <b>Operational limits must be controlled in the field</b> Limits such as water depth, equipment condition, and work area must be verified through direct supervision before and during operations.</li> <li>• <b>Management of Change (MOC) must be implemented</b> Any changes in equipment conditions (e.g., releasing the side pontoon) must go through a risk re-evaluation process before the unit is allowed to operate.</li> <li>• <b>Emergency preparedness is proven to be crucial</b> The quick response of the supervisor and ERT team in evacuating the operator demonstrates the importance of readiness and emergency response training.</li> </ul>
