## HSE Alert

### Kenali Titik Jepit, Cegah Cedera Tangan

# HSE Alert

## Identify Pinch Point, Prevent Hand Injury

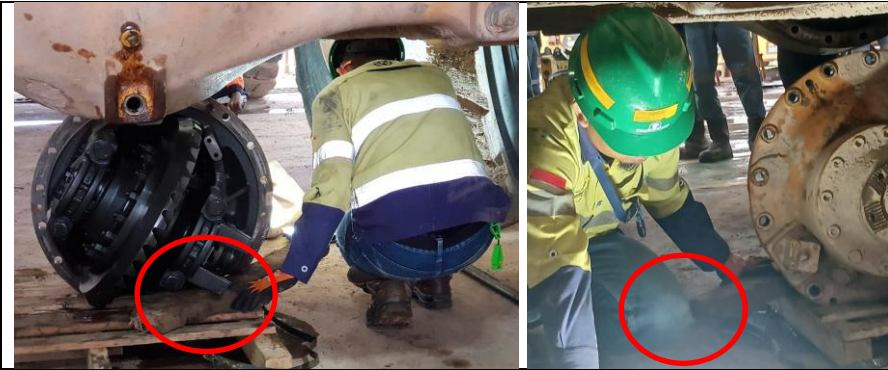
| <b>DESKRIPSI</b> | <p>Pada 23 Agustus 2026 sekitar pukul 03.00 WIB, telah terjadi insiden cedera jari terjepit yang menimpa seorang mekanik kontraktor di Workshop Highland. Insiden terjadi saat dua orang mekanik sedang melaksanakan pekerjaan penggantian diferensial unit ADT. Sebelum kejadian, diferensial telah diturunkan menggunakan lever block dan ditempatkan di atas palet kayu dengan penyangga berupa balok kayu untuk mencegah pergerakan. Setelah proses penurunan selesai, mekanik melakukan kegiatan merapikan material di bawah unit ADT.</p> <p>Pada saat yang bersamaan, kaki kiri mekanik secara tidak sengaja menyentuh balok kayu yang digunakan sebagai pengganjal diferensial. Akibatnya, diferensial mengalami pergeseran dan menyebabkan ujung jari telunjuk kiri mekanik terjepit di antara diferensial dan balok kayu. Mekanik kemudian secara refleks menarik tangannya dan menyadari bahwa jari telunjuk kirinya mengalami luka.</p> <p>Setelah kejadian, korban segera mendapatkan pertolongan dan dibawa ke Klinik PTAR untuk menjalani penanganan medis lebih lanjut.</p> <div data-bbox="416 763 1307 1131"> </div> <p style="text-align: center;">Ilustrasi Gambar Dari Rekonstruksi Kejadian</p> |

| <b>PELAJARAN PENTING</b> | <p>Beberapa hal penting dapat kita jadikan sebagai proses pembelajaran agar kejadian serupa tidak terulang kembali.</p> <ul style="list-style-type: none"> <li>• Selalu lakukan identifikasi bahaya dan penilaian risiko seperti HIRA, JSEA, dll untuk pekerjaan yang berpotensi line of fire, titik jepit dan cedera tangan sesuai prosedur yang berlaku.</li> <li>• Patuhi instruksi kerja aman dan tambahkan referensi buku panduan (Manual Book) untuk penanganan komponen, peralatan dengan berat dan dimensi yang berlebih.</li> <li>• Pengawasan melekat diwajibkan untuk memastikan pekerjaan saat penanganan komponen, peralatan dengan berat dan dimensi yang berlebih.</li> <li>• Pastikan seluruh peralatan, komponen, atau beban telah diamankan dan berada dalam kondisi stabil sehingga tidak ada kemungkinan pergerakan yang tidak terkendali akibat gravitasi atau dorongan benda lain.</li> <li>• Gunakan peralatan yang sesuai dan memadai untuk penanganan komponen, peralatan dengan berat dan dimensi yang berlebih.</li> <li>• Hindari bekerja di sekitar peralatan atau komponen yang belum aman atau berpotensi bergerak (line of fire).</li> <li>• Sediakan ruang kerja yang cukup agar pekerjaan dapat dilakukan dengan aman.</li> <li>• Penugasan pekerja baru dilakukan dengan mempertimbangkan jenis pekerjaan dan tingkat risiko. Pendampingan oleh pekerja senior wajib dilakukan selama masa percobaan.</li> <li>• Saat bekerja pastikan penglihatan tertuju pada tangan dan jari.</li> </ul> |

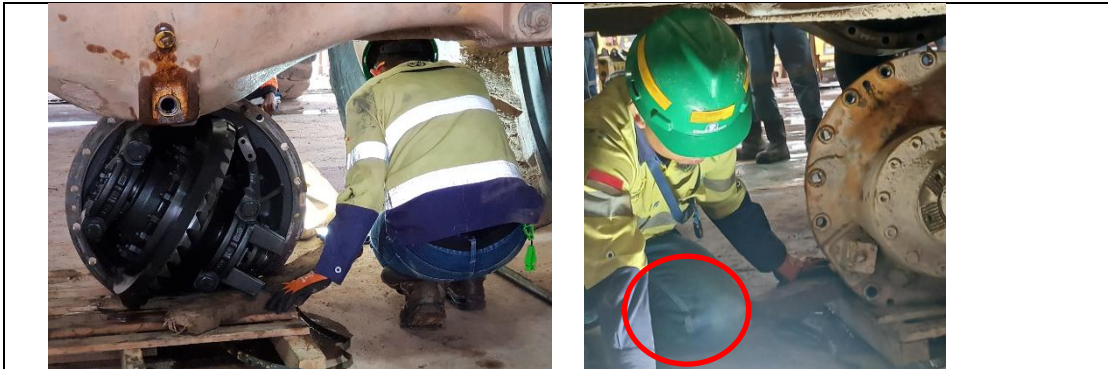
| <b>DESCRIPTION</b> | <p>On 23 August 2026 at approximately 03:00 WIB, a finger pinch injury incident occurred involving a contractor mechanic at the Highland Workshop. The incident occurred while two mechanics were replacing the ADT differential. Prior to the incident, the differential had been lowered using a lever block and placed on a wooden pallet, with wooden blocks used as supports to prevent movement. After the lowering process was completed, the mechanics proceeded to tidy up the materials underneath the ADT unit.</p> <p>At the same time, the mechanic's left foot accidentally came into contact with the wooden block being used as a chock for the differential. As a result, the differential shifted, causing the tip of the mechanic's left index finger to become trapped between the differential and the wooden block. The mechanic instinctively pulled his hand away and realized that his left index finger had sustained an injury.</p> <p>Following the incident, the injured person immediately received first aid and was transported to the PTAR Clinic for further medical treatment.</p> <div data-bbox="347 705 1460 1072"> </div> <p style="text-align: center;">Illustration of the Incident Reconstruction</p> |

| <b>KEY LEARNING</b> | <p>The following are lessons learned to prevent recurrence of the incident:</p> <ul style="list-style-type: none"> <li>• Always conduct hazard identification and risk assessment, such as HIRA, JSEA, etc., for work involving potential line-of-fire hazards, pinch points, and hand injury risks, in accordance with applicable procedures.</li> <li>• Comply with safe work instructions and refer to additional guidance, such as the relevant Manual Book, when handling components or equipment with excessive weight and dimensions.</li> <li>• Close supervision is mandatory to ensure safe work practices during the handling of components or equipment with excessive weight and dimensions.</li> <li>• Ensure that all equipment, components, or loads are properly secured and in a stable condition, with no possibility of uncontrolled movement due to gravity or contact with other objects.</li> <li>• Use appropriate and adequate equipment when handling components or equipment with excessive weight and dimensions.</li> <li>• Avoid working around equipment or components that have not been properly secured or have the potential to move unexpectedly (line of fire).</li> <li>• Provide sufficient working space to ensure that the work can be performed safely.</li> <li>• The assignment of new workers must take into consideration the type of work and its level of risk. Mentoring by senior workers is mandatory during the probationary period.</li> <li>• While working, always ensure that your attention and line of sight are focused on your hands and fingers.</li> </ul> |
